Lift Pit Liners

Introduction

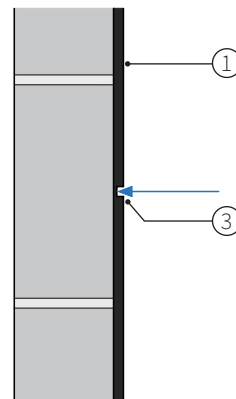
1. Fully bonded barrier preventing water from tracking from a defect in the membrane to a crack/joint in the wall.
2. Partially bonded barrier allowing water to track.
3. Defect in the barrier.

Barrier material choices within BS8102 is focused on sheets, liquids and coatings. These materials share a critical feature in that they bond to the substrate as they are applied. This bond to the structure is key in avoiding the risk of water tracking and preventing lateral migration of water from a defect in the liner. Whereas, the predominant material for lift pit liners is glass reinforced plastic (GRP) which is formed into a lift pit shape, loosely laid or placed into position and 'sandwiched' by follow on material. This is not bonded in the same way as an applied material e.g. sheets, liquids and coatings and as such has a higher risk of lateral migration of water from a defect in the liner.
